Temporal and Spatial Variation Study on Corrosion of High-Strength Steel Wires in the Suspender of CFST Arch Bridge

Abstract: The corrosion and degradation behavior of high-strength steel wires during service directly affect the safety and usability of suspenders in steel pipe concrete arch bridges. In this study, three different types of specimens were fabricated using steel wires extracted from the suspenders of an 11-year-old in-service arch bridge and subjected to accelerated corrosion tests with acetic acid. Considering the differential diffusion processes of corrosion factors caused by varying degrees of damage to the suspender sheath, the spatial corrosion variability of steel wires at different positions within the suspender cross-section was investigated. Experimental results indicated a two-stage characteristic in the corrosion process of individual galvanized steel wire samples. In the first corrosion stage, the microstructure on the corroded steel wire surface evolved from a dense crystalline structure to a porous one. In the second corrosion stage, corrosion products accumulate on the steel wire substrate, subsequently further aggregating into sheet-like structures. T

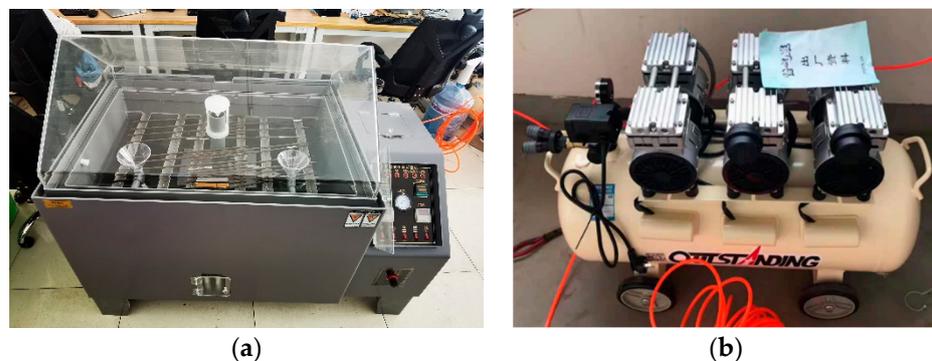
Figure 1. Salt spray test equipment. (a) Salt spray chamber, (b) Air compressor.

The corrosion test was conducted using the salt spray test machine shown in Figure 1. The external dimensions of the chamber are 134 mm × 820 mm × 1080 mm, and the internal dimensions are 900 mm × 500 mm × 600 mm. The salt spray test machine utilizes Bernoulli's principle to draw the corrosive liquid, pressurize and atomize it through an air compressor, and evenly spray the atomized corrosion solution inside the test chamber using nozzles. Simultaneously, the temperature sensing system maintains the temperature within the specified range to ensure a stable corrosive environment inside the chamber, with the corrosion environment temperature set at 35 °C for acetic acid salt spray corrosion tests.

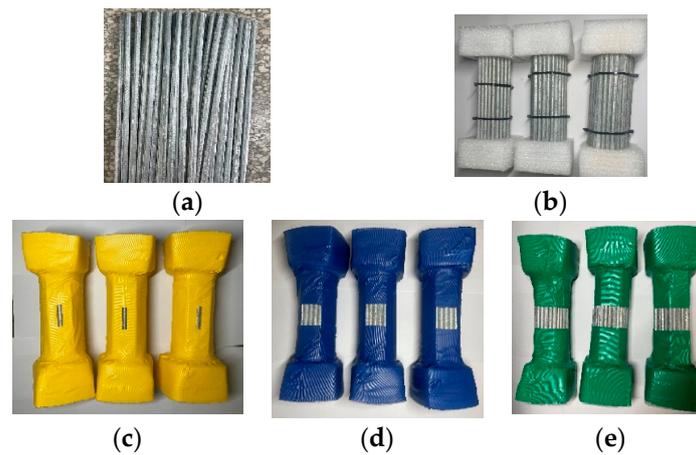
Figure 2. Corrosion test wire specimens. (a) The Single Steel Wire Specimen, (b) Protection failure specimen, (c) Strip-shaped Damage, (d) square block damage, (e) semi-circular damage.

- (1) Type I Specimens (Single wire specimen): The wires disassembled from the suspenders were cut into 200 mm steel bars. The specimens were cleaned with ethanol and labeled, as shown in Figure 2a. These specimens were employed to investigate the evolving corrosion states of individual steel wires during accelerated corrosion testing and the corresponding microstructural changes on the corroded steel wire surfaces.

- (2) Type II Specimens (Protection failure specimen): Comprising 61 wires, each 200 mm in length, these specimens were bundled according to the original arrangement of wires within the suspenders. Before bundling, the steel wire needs to be cleaned, weighed, and properly labeled. The ends of the wire bundle were secured using custom-made polytetrafluoroethylene molds, as depicted in Figure 2b. The specimens with complete failure of simulated suspender corrosion protection measures can be utilized to investigate the differences in the corrosion development process of the steel wires.

- (3) Type III Specimens (Sheath-damaged bundle specimens): Based on the Type II specimens, to simulate the protective sheath, the bundled wires were covered with waterproof material and further reinforced by wrapping with waterproof tape. This treatment ensures waterproofing and facilitates easy cutting to simulate various damaged forms on the protective material. Based on the results of field investigations on in-service bridges, three simulated damage forms are considered: (a) Strip-like damage, as shown in Figure 2c. (b) Rectangular sheath damage, as shown in Figure 2d. (c) Semi-circular damage, as shown in Figure 2e. Considering the impact of the shape of suspender sheath damage on the diffusion of corrosion factors, utilizing such specimens enables the exploration of spatial corrosion differences among suspender steel wires under different diffusion modes.

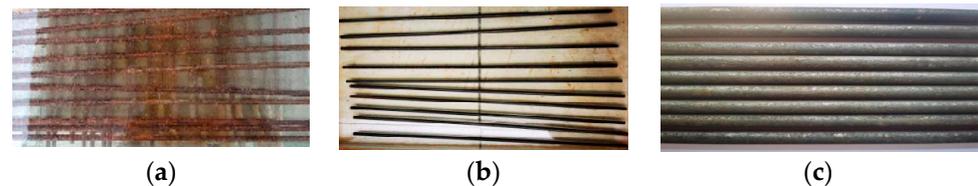
Figure 3. Rust removal of a single steel wire specimen. (a) Corroded steel wire original appearance, (b) Derusting with hydrochloric acid, (c) De-rusting with steel wire.

To facilitate subsequent observation and analysis of the steel wire surfaces, it is necessary to conduct rust removal treatments on the steel wires. A 10% diluted hydrochloric acid reagent with a corrosion inhibitor was used to pick up the corroded high-strength steel wire. The corroded samples were placed in a glass container, diluted with hydrochloric acid, soaked for 5–6 min, and then cleaned. The acid-washed high-strength steel wire was placed in a $\text{Ca}(\text{OH})_2$ solution to neutralize the residual hydrochloric acid on the surface, and then placed in clean water (not higher than 40 °C) to wash off the residual $\text{Ca}(\text{OH})_2$ on the high-strength steel wire [41]. Finally, the steel wire was dried, as shown in Figure 3. The specimen was cut to a length of 50 mm for electron microscopy.

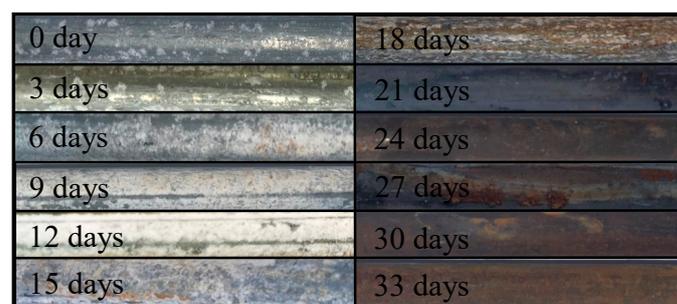
Figure 4. Macroscopic surface of corroded steel wire.

Before conducting microscopic observations on the corroded steel wire samples, the macroscopic corrosion morphology changes of the Type I specimen were first introduced based on the salt spray test results, as shown in Figure 4. From the figure, it can be observed that in the initial stage of the corrosion experiment, white flocculent oxide of the galvanized layer gradually accumulated on the surface of the steel wire. When the corrosion time reached 15 days, the oxide of the galvanized layer peeled off, and the steel wire substrate was corroded. The color of the corrosion products gradually transitioned from white to yellow, and finally, starting after 24 days, reddish-brown oxides gradually covered the surface of the steel wire.

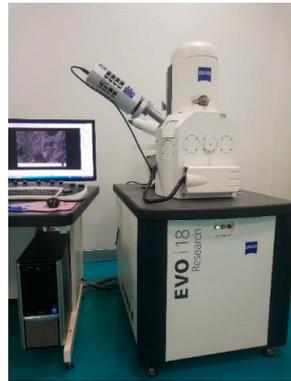
Figure 5. Field emission scanning electron microscope.

Field emission scanning electron microscopy (SEM) was employed for the examination of the surface morphology of corroded steel wires, as depicted in Figure 5. In the early stages of corrosion, minute cracks have been observed to initiate on the surface of the steel wire, as depicted in Figure 6. The volumetric expansion of corrosion products has led to the appearance of surface cracks on the steel wire. With the increasing exposure time of the steel wire in the corrosive environment, microscopic changes have gradually occurred on the corroded surface. Observations under an electron microscope at 5000× magnification revealed four stages of surface morphology changes in the steel wire, as illustrated in Figure 7. Initially, the galvanized layer appears intact, uniformly covering the steel wire substrate, as shown in Figure 7a. During the initial stages of corrosion, granular corrosion products from the galvanized layer adhere to the corroded area, gradually exposing the

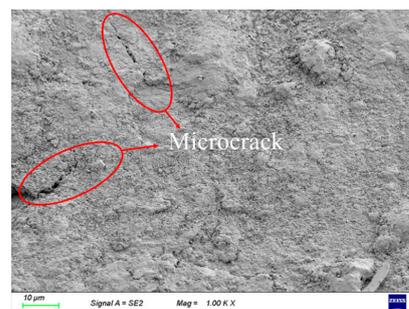
Figure 6. Incipient Crack Formation on the Steel Wire Surface.

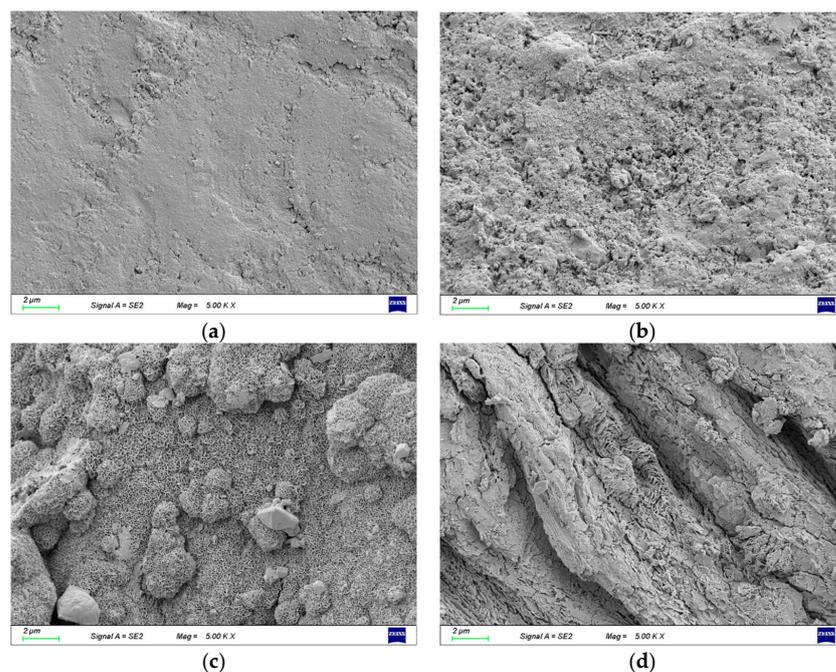
Figure 7. The evolution of the microscopic state on the surface of the steel wire. (a) Initial appearance; (b) 10 days; (c) 21 days; (d) 31 days.

steel wire substrate, as shown in Figure 7b. As the corrosion progresses, uniformly small granular products accumulate, becoming more porous in morphology. At this stage, the corroding agents have fully accessed the steel wire substrate, resulting in the formation of iron oxide, which presents a cotton-like appearance, as depicted in Figure 7c. Upon prolonged exposure to the corrosive environment, abundant corrosion products from the steel wire substrate accumulate, exhibiting characteristics of layered stacking and a more porous physical state compared to previous products, as shown in Figure 7d.

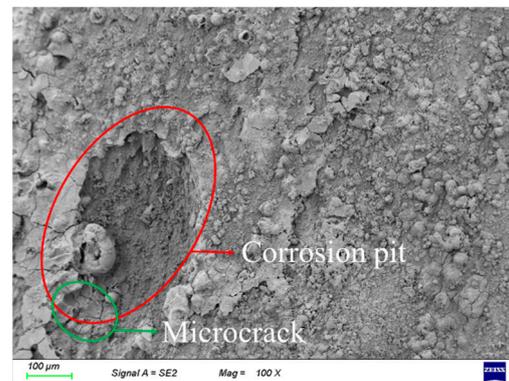
Figure 8. Surface Corrosion Pits and Cracks in Corroded Steel Wire.

It is noteworthy that, as the stacked corrosion products naturally peel off, corrosion pits are directly exposed on the surface of the steel wire substrate. Simultaneously, some scattered cracks appeared near the corrosion pits. As shown in Figure 8, it can be observed that corrosion pits lead to cross-sectional loss of the steel wire, coupled with stress concentration caused by the additional presence of cracks, which may significantly compromise the load-bearing capacity of the steel wire and reduce the performance of its products.

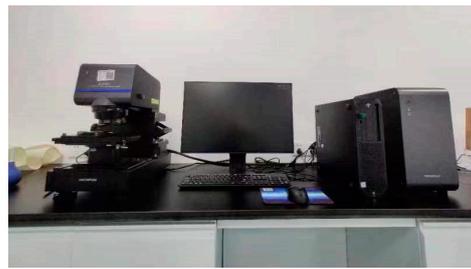
Figure 9. Confocal Laser Scanning Microscope.

The steel wire specimens were scanned using a confocal laser scanning microscope to examine the surface (accuracy $0.12 \mu\text{m}$). The equipment used in this study is shown in Figure 9. Typical surface scan results for the steel wire are shown in Figure 10. The surface conditions of the steel wire can be more intuitively visualized with 3D scanning and contour maps. The initial state of the steel wire surface appears relatively smooth, with a dense zinc coating covering the surface, as depicted in Figure 10a,b. In Figure 10c,d, it is observed that the zinc coating of the steel wire is nearly depleted, exposing a large area of the steel wire substrate. The corrosive factors in the environment continue to interact with the steel wire substrate surface. After removing the corrosion products covering the surface, the pitted areas on the steel wire surface are exposed. It is evident from Figure 10e,f that the steel wire surface rapidly becomes rough. As depicted in Figure 10g,h, with the increasing severity of corrosion, small corrosion pits on the surface gradually merge into larger ones, leading to a loss of cross-sectional area. Consequently, the height differential on the surface of the steel wire also increases. The relationship between specimen roughness and corrosion time is shown in Figure 11, indicating that as corrosion increases, the average roughness of the specimens gradually increases.

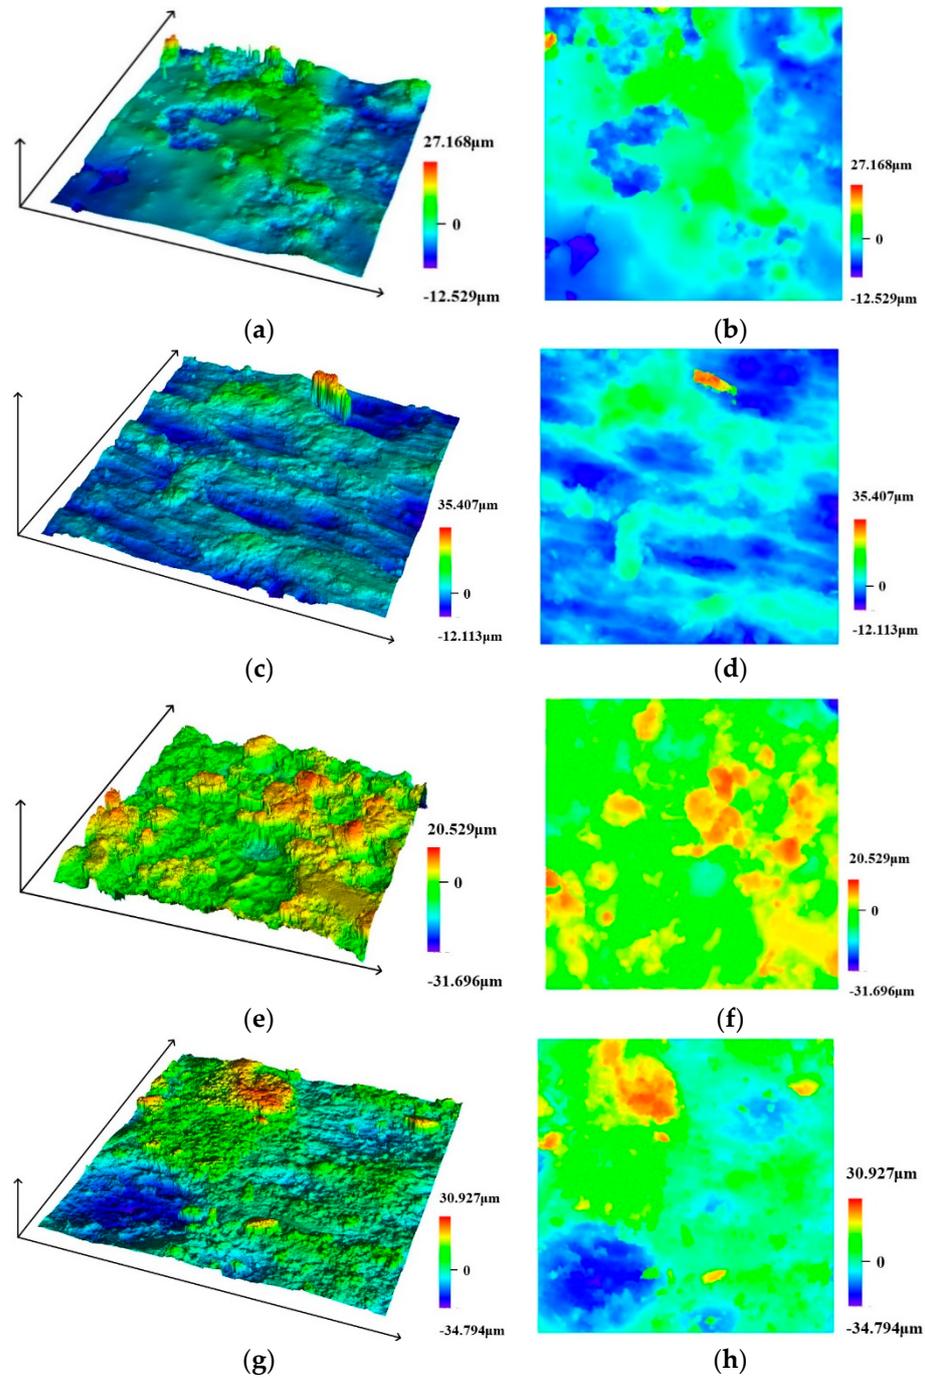
Figure 10. Laser microscope scanning results. (a) Initial appearance-3D, (b) Initial appearance-2D, (c) 10 days-3D, (d) 10 days-2D, (e) 21 days-3D, (f) 21 days-2D, (g) 31 days-3D, (h) 31 days-2D.

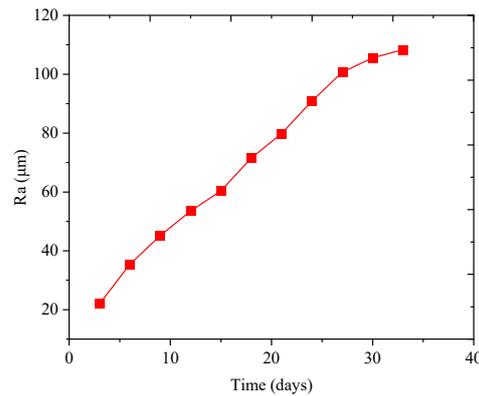
Figure 11. The relationship between roughness and time.

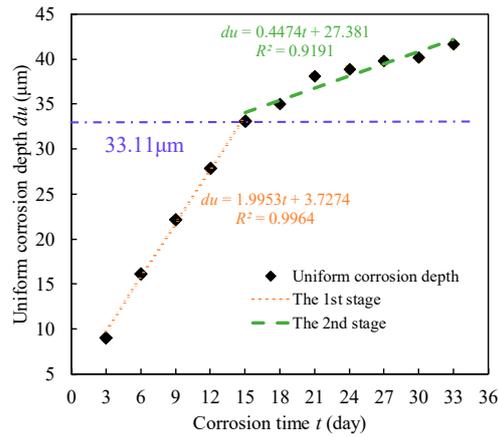
Figure 12. Uniform corrosion depth.

Based on the detection results of Type I corrosion specimens, the variation in steel wire corrosion depth with the corrosion specimens is shown in Figure 12. The corrosion depth gradually deepens with time, exhibiting a distinct two-stage characteristic. In the first stage, the corrosion depth increases rapidly, while in the second stage, the rate slows down, with a division point around 15 days. The corrosion process of the zinc coating on the steel wire is in the first stage, followed by the corrosion of the steel wire substrate, which corresponds to the second stage in the graph. Regression analysis of the data in the graph allows the average corrosion depth of the wire to be described as:

$$\begin{cases} d_{u,average}(t) = 1.9953t + 3.7274 \\ d_{u,average}(t) = 0.4474t + 27.381 \end{cases} \quad (3)$$

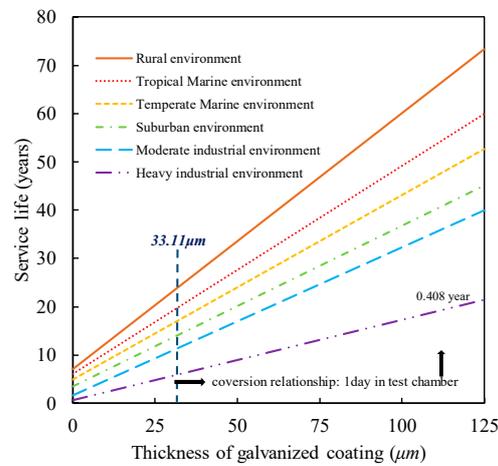
Figure 13. Corrosion-Time Conversion Relationship.

In order to establish the correspondence between the corrosion state of the steel wire in the accelerated salt spray corrosion test and the actual environmental corrosion conditions, this paper adopts the results of Marder's outdoor corrosion test [43], based on which a correlation graph between the two is drawn, as shown in Figure 13. The bridge's service area is located in a heavy industrial province. From this, it can be deduced that one day of salt spray testing is equivalent to corrosion occurring over 0.408 years in harsh industrial environments.

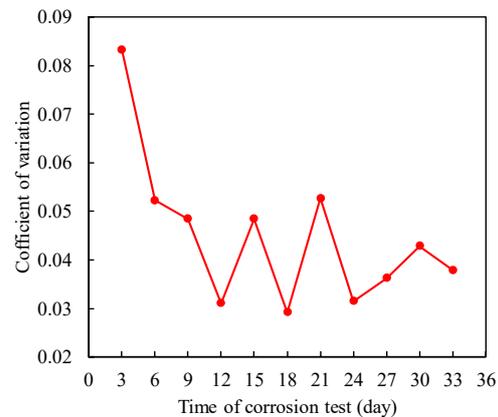
Figure 14. Correlation coefficient of uniform corrosion depth.

Figure 14 provides the correlation coefficients for the uniform corrosion depth of the steel wires in this experiment. The trend depicted in the figure indicates that from the initial stages, the variability of the uniform corrosion depth gradually decreases, ultimately reaching a stable state.

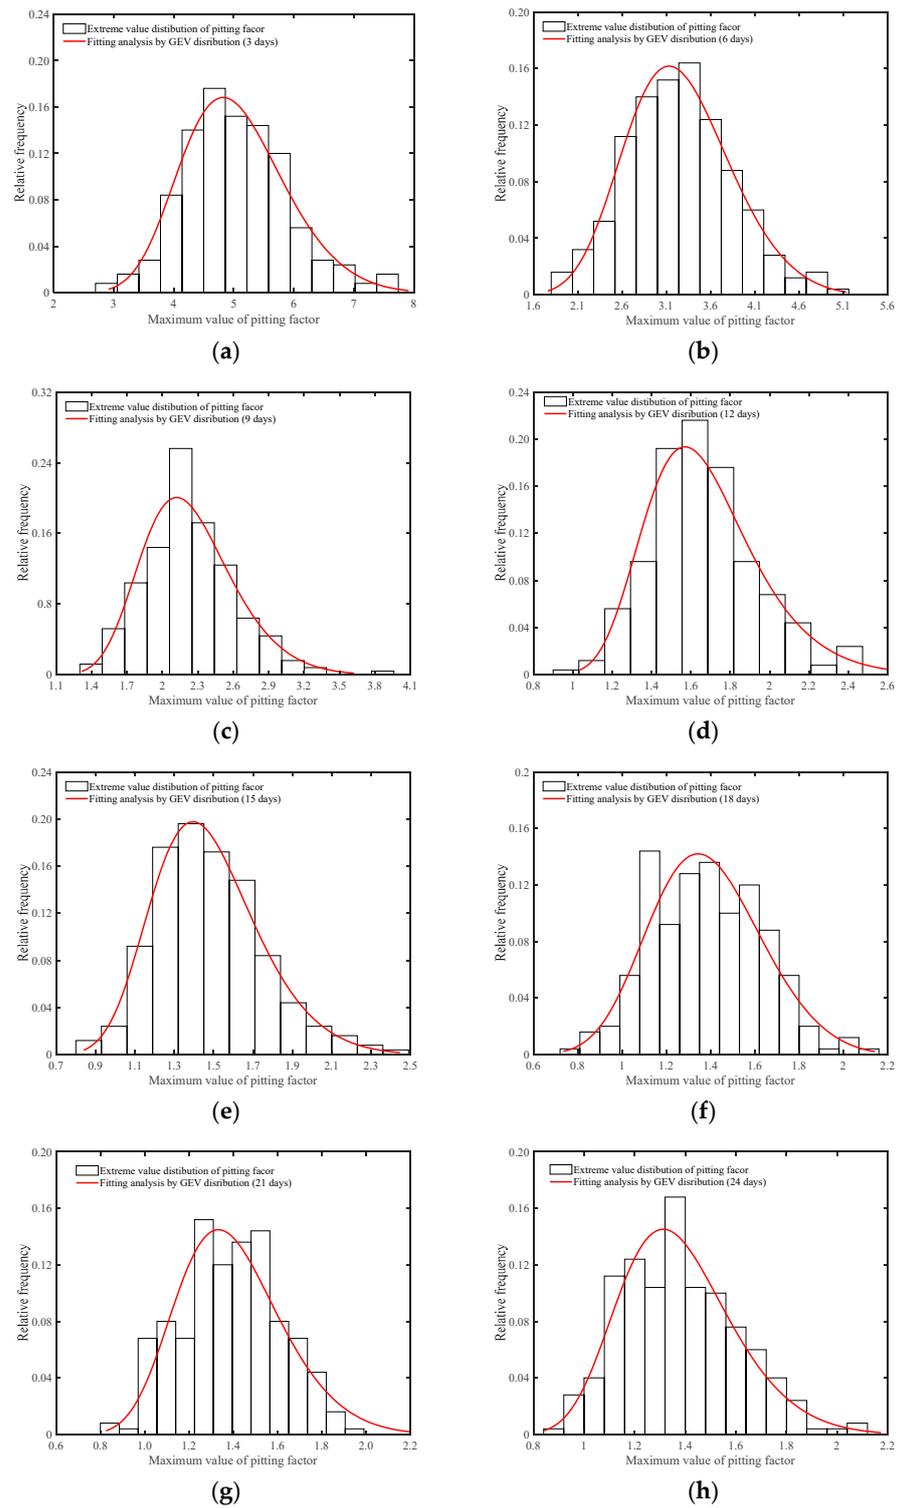
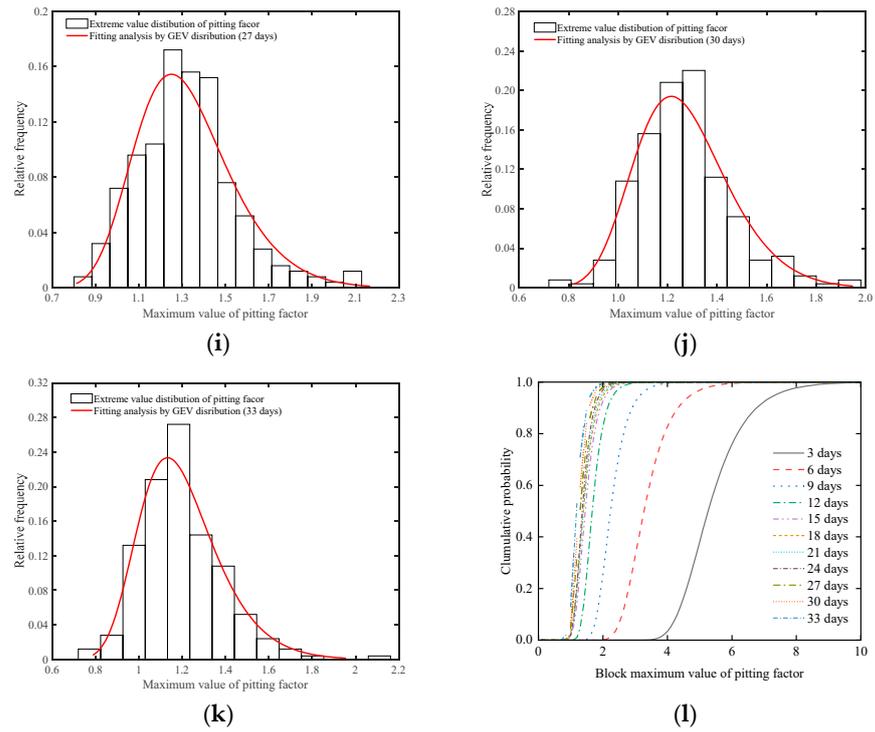
Figure 15. Analyzing pitting factor extremes with the GEV distribution method. (a) Accelerated corrosion for 3 days; (b) Accelerated corrosion for 6 days; (c) Accelerated corrosion for 9 days; (d) Accelerated corrosion for 12 days; (e) Accelerated corrosion for 15 days; (f) Accelerated corrosion for 18 days; (g) Accelerated corrosion for 21 days; (h) Accelerated corrosion for 24 days (i) Accelerated corrosion for 27 days; (j) Accelerated corrosion for 30 days; (k) Accelerated corrosion for 33 days; (l) Cumulative maximum value of pitting factor.

where μ , σ , and ξ denote the location parameter, scale parameter, and shape parameter, respectively. t denotes the corrosion time. For specimens at different corrosion time points, Figure 15a–k presents the fitting analysis results of the dynamic distribution of the GEV.

Figure 15l presents the cumulative probability density of the maximum pitting factor for specimens in each accelerated corrosion time segment. According to the modeling calculation results of Equation (5), the shape parameter ranges between -0.01706 and 0.0297 , indicating that the shape parameter is near 0. This means that the maximum pitting factor samples from the sampling area can be described using a Type I extreme value distribution. Based on the two-stage characteristics revealed by the corrosion results of the steel wire, the fitting results of the unknown parameters and scale parameters of the Type I extreme value distribution can be obtained from Figure 16. It can be observed that in the first stage of corrosion development, the changes in the location and scale parameters of the Type I extreme value distribution follow an exponential decrease pattern, while during the second stage of corrosion development, the changes in the location parameter and scale parameter of the Type I extreme value distribution exhibit linear variations.

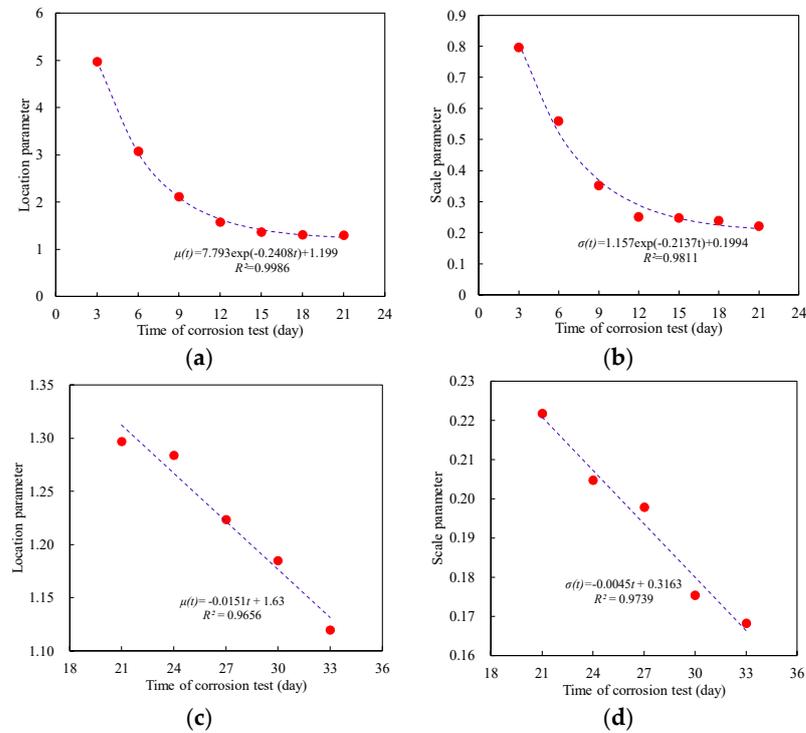
Figure 16. Variation in distribution parameters of Type I extreme value distribution. (a) Location parameter of the first stage; (b) Scale parameter of the first stage; (c) Location parameter of the second stage; (d) Scale parameter of the second stage.

As the corrosion time increases, both the location parameter and scale parameter exhibit exponential decay during the first corrosion stage, following the pattern:

Additionally, during the second corrosion stage, both the location parameter and scale parameter linearly decrease with the extension of corrosion time, conforming to the pattern:

$$\begin{cases} \mu(t) = -0.0151t + 1.63 \\ \sigma(t) = -0.0045t + 0.3163 \end{cases} \quad (7)$$

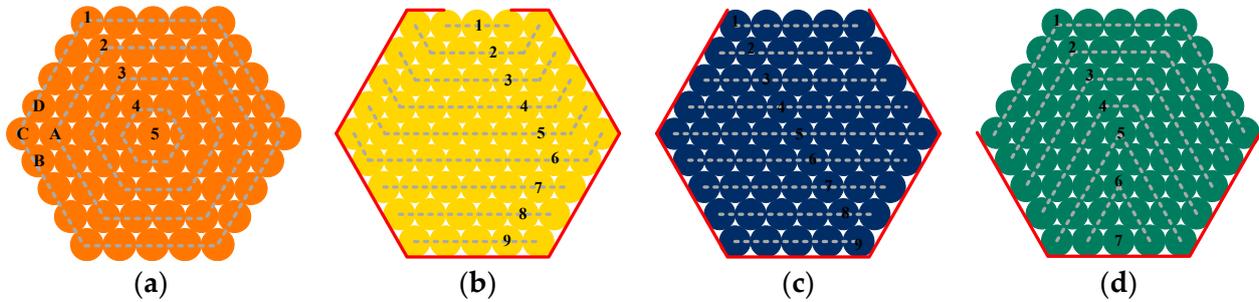
Figure 17. Schematic Diagram of Layered Configuration for Steel Wire Specimens. (a) Protection failure specimen; (b) Linear sheath damage; (c) Rectangular sheath damage; (d) Semi-circular sheath damage.

In this experiment, for a clear description of the experimental phenomena, the assumption of the shortest corrosion factor diffusion path was adopted. The steel wires located at different positions were stratified and numbered. In the experiment, starting from the simulated damage location, the stratification method for the Type II and Type III specimens is illustrated in Figure 17.

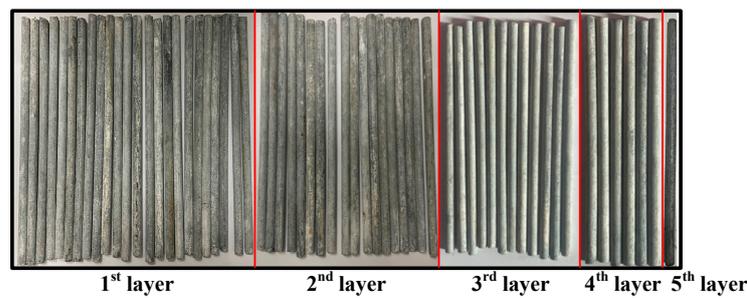
Figure 18. Corrosion morphology of wires.

Taking the Type II specimen with a corrosion time of 90 days as an example, Figure 18 illustrates the macroscopic corrosion states of wires in each layer after specimen dissection. It is observed that the extent of corrosion decreases with the increase in the number of layers. The measured distribution of δ and the results of the fitting analysis are depicted in Figure 19. It can be noted that the differential factor in the corrosion process of adjacent layer wires can be described by a normal distribution, with mean and coefficient of variation values of 0.7074 and 0.3028, respectively.

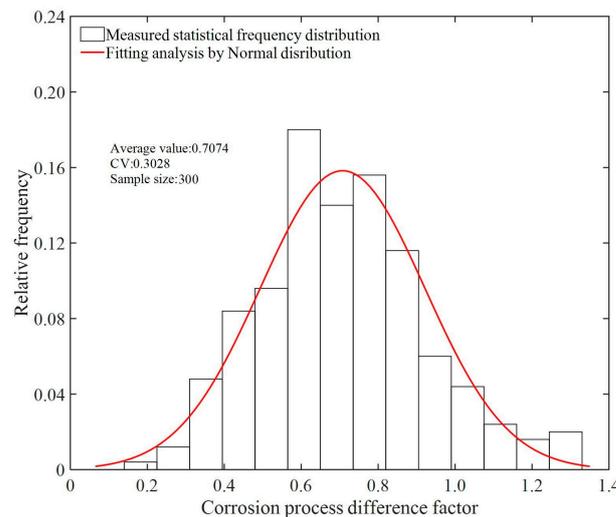
Figure 19. Normal distribution fitting analysis.

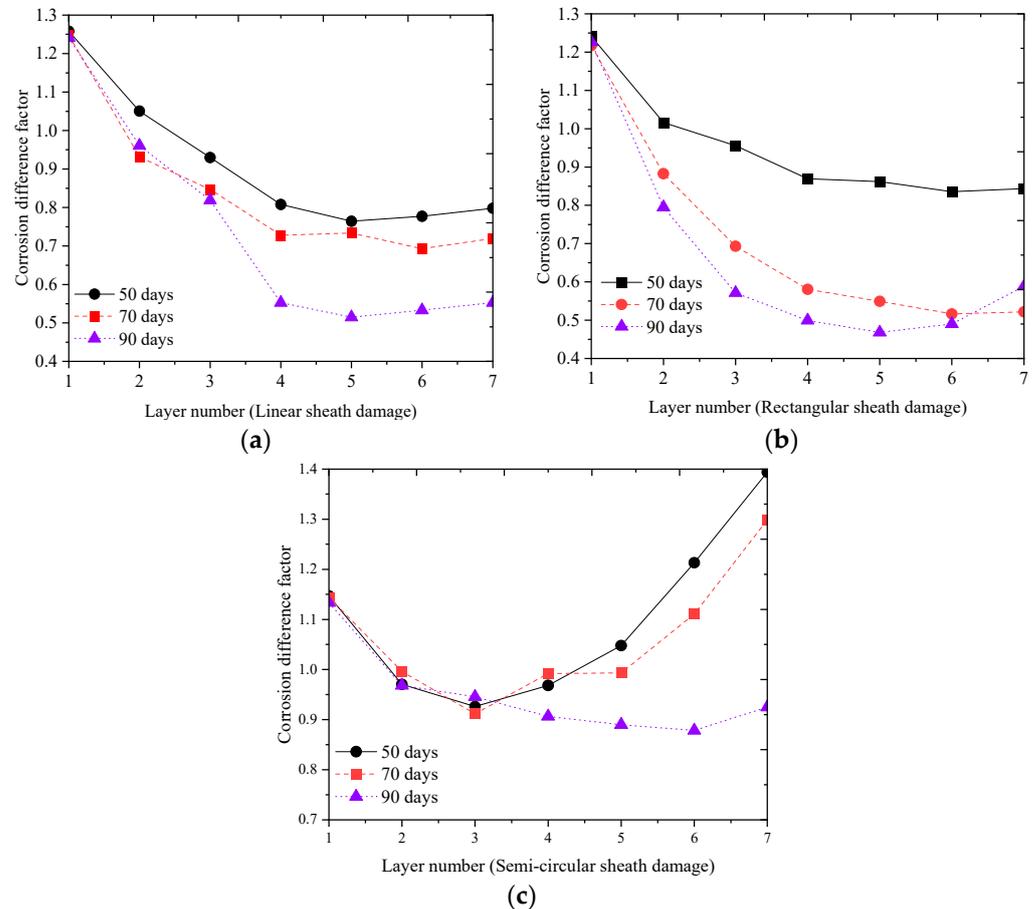
Figure 20. Differential Analysis of Corrosion Process Considering Sheath Damage. (a) Linear sheath damage; (b) Rectangular sheath damage; (c) Semi-circular sheath damage.

For the type III of specimen, based on the analytical solution of Equations (10) and (11), the parameters of $\theta_{i,j \rightarrow 1}$ are presented in the line chart in Figure 20a–c. The findings demonstrate a pronounced influence of the shape of sheath damage on the spatial corrosion variability of steel wires within the suspender cross-section of arch bridges. With increasing corrosion time, the overall corrosion level difference between the layers of steel wires within the suspender decreases. The primary factors contributing to this phenomenon encompass

the shape of sheath damage, the exposed surface area of the steel wires to the corrosive environment, and the deposition of corrosion by-products. It is evident that the process of corrosion erosion of the steel wire in the corrosive environment is significantly influenced by the shape of the sheath damage.

Among the three different sheath damage specimens, the wire samples with rectangular sheath damage and linear sheath damage exhibit stronger spatial corrosion variability compared to those with semi-circular damages. The genesis of this phenomenon is attributed to the hindering effect of sheath damage on the diffusion of corrosion factors. In certain circumstances, the corrosion severity of the innermost steel wires exceeds that of the outer layers, attributable to the heightened propensity for corrosion factor accumulation within the internal wire environment, ultimately impeding their diffusion and dilution.
